PHOTOGRAPHIC LOG

Client Name: Town of Guilford

Site Location: Guilford High School, 605 New England Road, Guilford, CT

Project No. T-0249

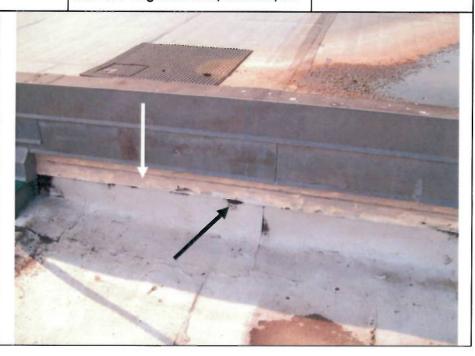
Photo No.

Source Identification Number: 12

Description: Grey caulk at copper flashings, white/black coating on flashing, and black asphalt top of edge flashing seams.

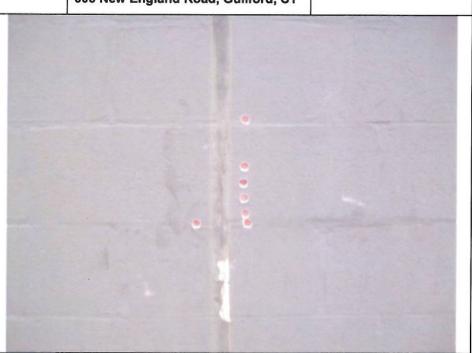
Photo No. 2

Number: 9

Description: Beige caulk in CMU expansion joints.

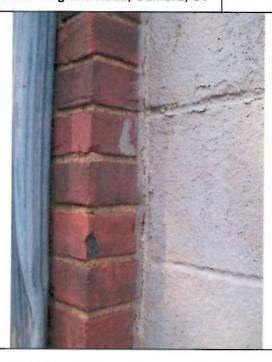
Photo No.

Number: 6

Description: Grey caulk at CMU/brick wall joint

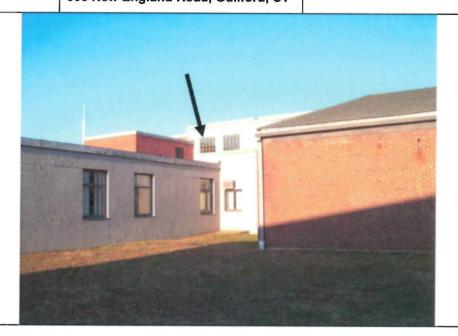
Photo No. Date: 08/2012

Number: 7

Description: Grey caulk at gym window frame/sill

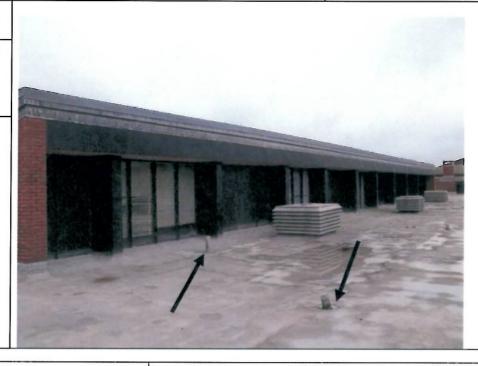
Photo No.

Number: 8

Description: Felt beneath black asphalt vents, portholes, drain pans.

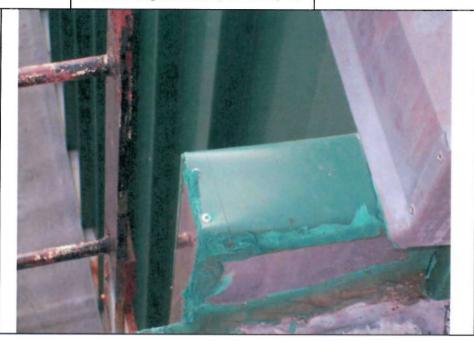
Photo No. Date: 08/2012

Source Identification Number: 14

Description: Green rubbery caulk in metal siding

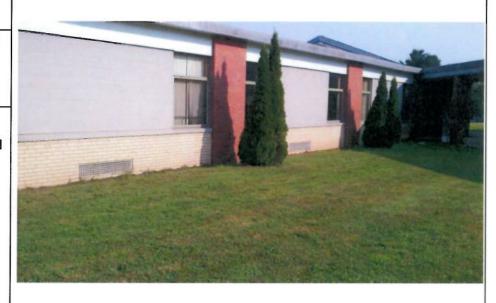
Photo No.

Source Identification Number: 30 & 31 &

32

Description: Courtyard overview for photos 8, 9, 10, 11 & 12

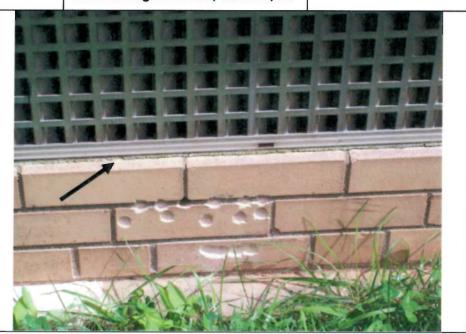
Photo No.

Source Identification Number: 30 & 31

Description: Grey caulk at vent louvers

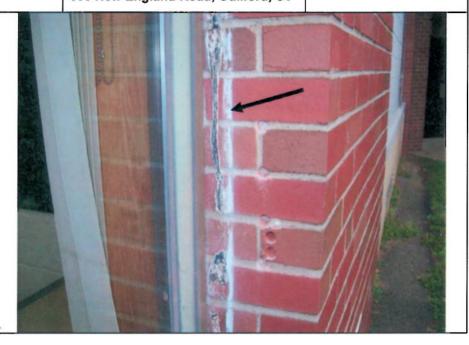
Photo No.

Source Identification Number: 30 & 31

Description: Residual grey window frame caulk

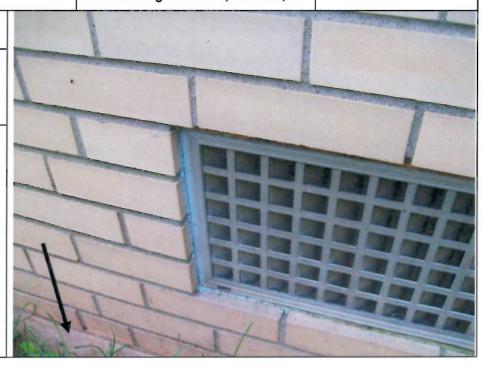
Photo No. 10 Date: 08/2012

Source Identification Number: 30 & 31

Description: Concrete foundation below glazed brick wall

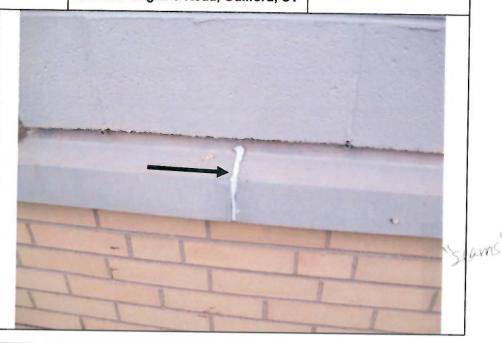
Photo No.

Source Identification Number: 32

Description: White caulk on building seems/sills

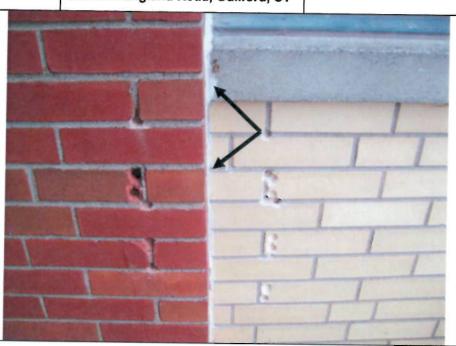
Photo No. 12

Number: 32

Description: White caulk on building seems/sills

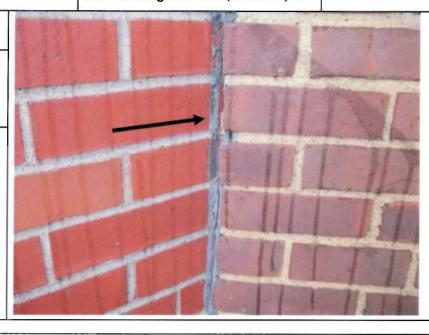
Photo No. 13 Date: 08/2012

Number: 33

Description: Dark grey caulk at building transition

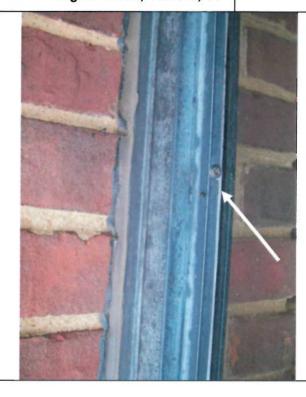
Photo No. Date: 08/2012

Source Identification Number: 39

Description: White glazing in metal window frames

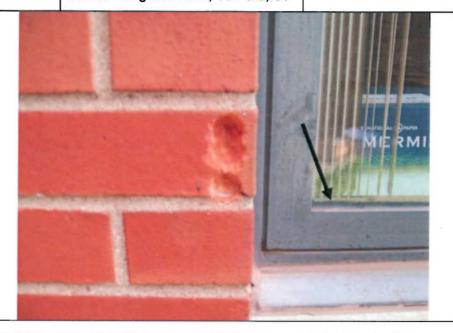
Photo No. 15 Date: 08/2012

Number: 41

Description: Black glazing in metal window frames

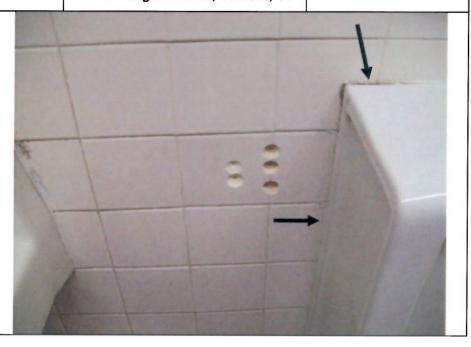
Photo No.

Number: 51

Description: Tan caulk at urinals

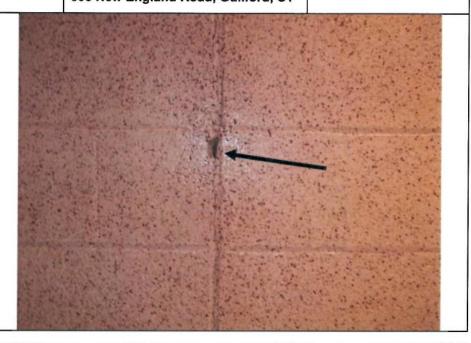
Photo No. 17 Date: 08/2012

Number: 53

Description: Tan caulk at CMU expansion joints

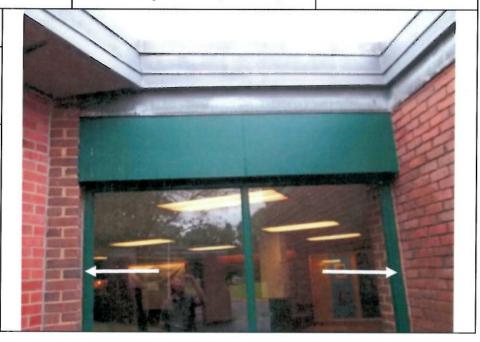
Photo No. Date: 08/2012

Source Identification Number: 54

Description: White window/door caulk

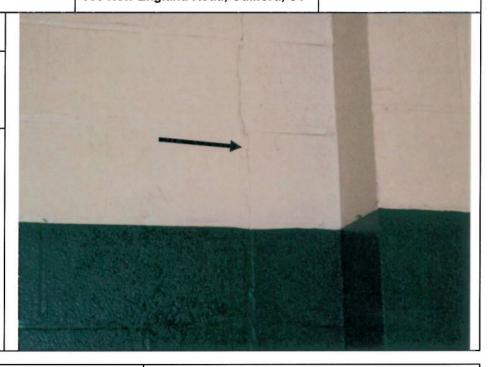
Photo No.

Number: 55

Description: Hard grey expansion joint caulk

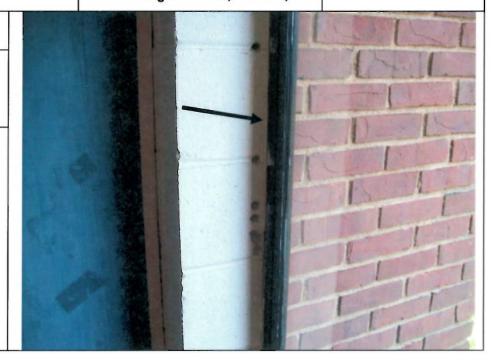
Photo No. Date: 08/2012

Source Identification Number: 56

Description: White caulk at metal window frame

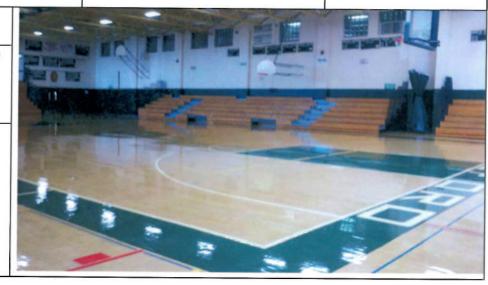
Photo No. 21 Date: 08/2012

Number: 59

Description: Floor wax on gym floor

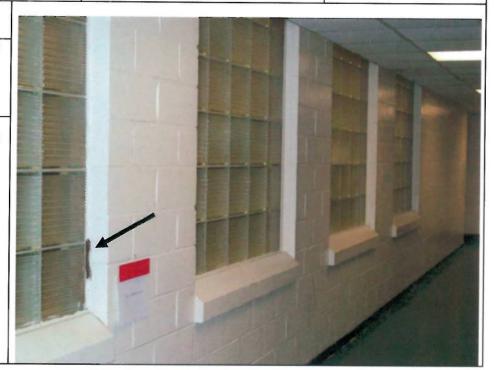
Photo No. 22 Date: 08/2012

Number: 60

Description: Tan caulk at architectural glass block

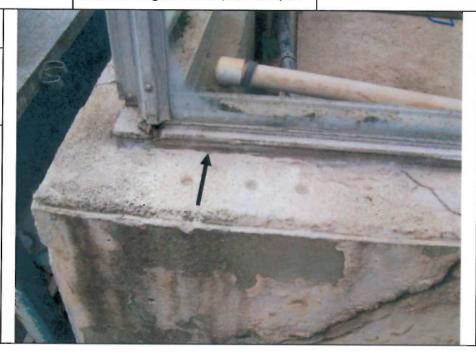
Photo No. 23

Number: 61

Description: Caulk at greenhouse

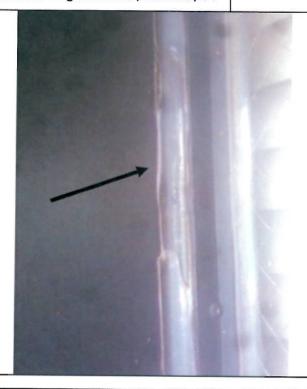
Photo No. 24 B Date: 08/2012

Number: 16

Description: Clear caulk on metal window panels and black calk at facia seams metal

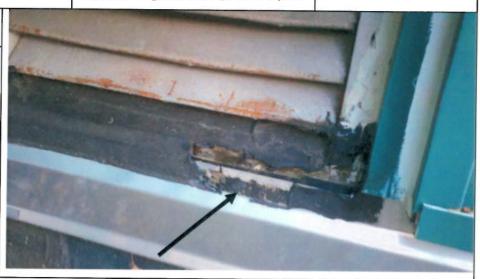
Photo No. Date: 08/2012

Source Identification Number: 20

Description: Black caulk at louver

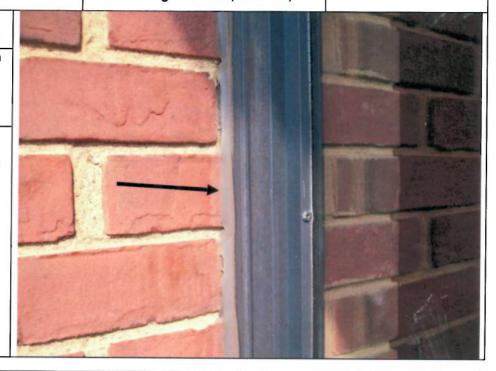
Photo No. 26 Date: 08/2012

Source Identification Number: 23

Description: Grey caulk at metal door/window frames and dark grey rubbery caulk at window frame

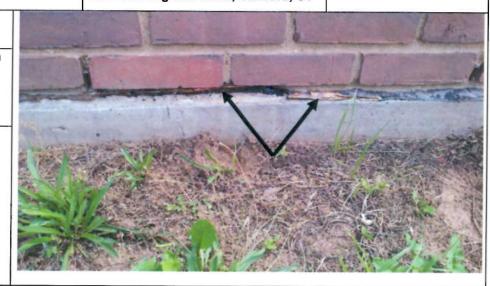
Photo No. 28 Date: 08/2012

Number: 34

Description: Black asphalt concrete flashing

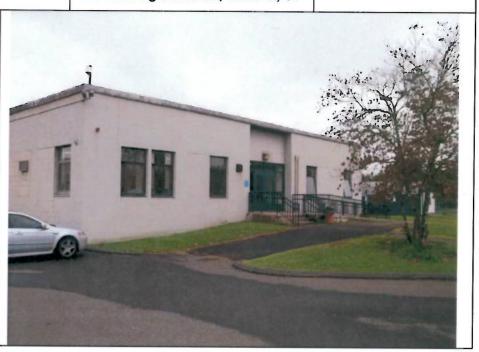
Photo No. 29 A Date: 08/2012

Number: 40

Description: Black glazing in metal window frames

Typical windows in 1958 construction

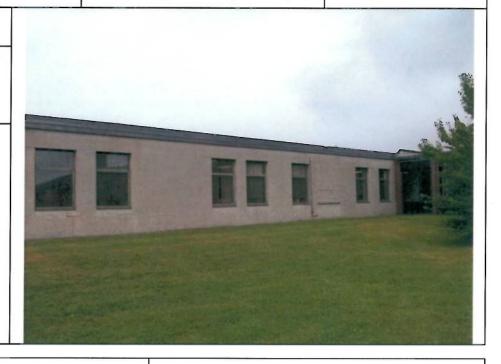
Photo No. 29 B Date: 08/2012

Number: 40

Description: Black glazing in metal window frames

Typical windows in 1958 construction

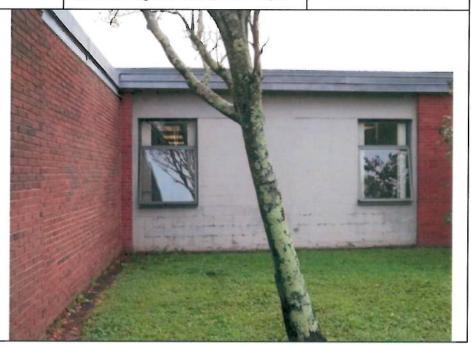
Photo No. 29 C Date: 08/2012

Number: 40

Description: Black glazing in metal window frames

Typical windows in 1958 construction

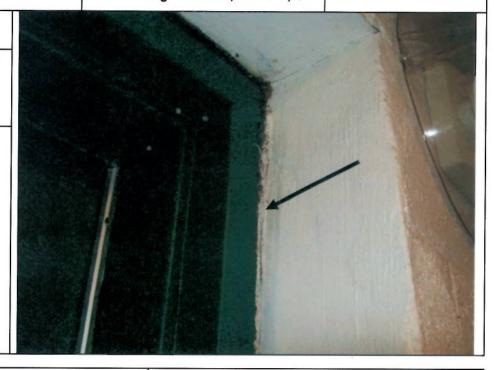
Photo No. 30 Date: 08/2012

Source Identification Number: 42

Description: White brittle metal window frame caulk

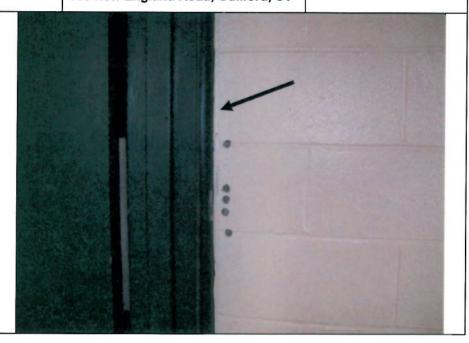
Photo No. Date: 08/2012

Source Identification Number: 43

Description: White rubbery metal door frame and expansion joint caulk

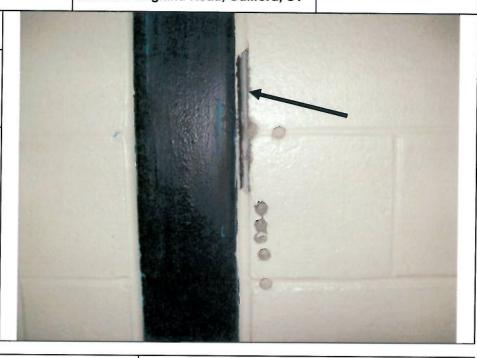
Photo No. 31 B Date: 08/2012

Source Identification Number: 43

Description: White rubbery metal door frame and expansion joint caulk

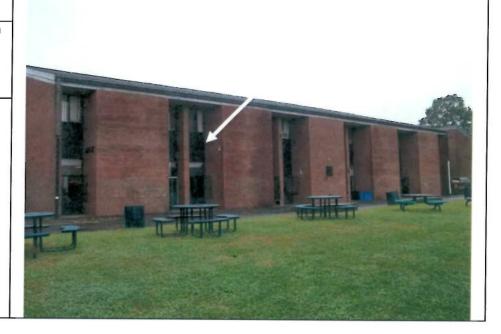
Photo No. Date: 32 A 08/2012

Source Identification Number: 45

Description: Black metal window/door frame caulk and black glazing

Typical large windows in 1968 construction

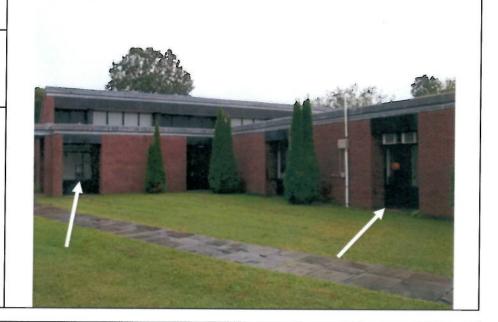
Photo No. 32 B Date: 08/2012

Source Identification Number: 45

Description: Black metal window/door frame caulk

Typical windows in 1968 construction

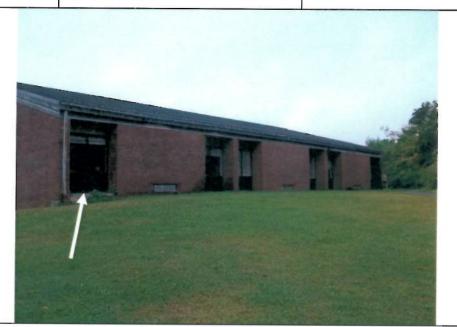
Photo No. 32 C Date: 08/2012

Source Identification Number: 45

Description: Black metal window/door frame caulk

Typical windows in 1968 construction

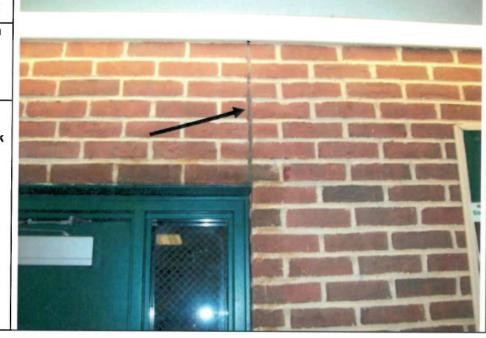
Photo No. 33 C

Source Identification Number: 47 & 48

Description: Grey/white expansion joint caulk

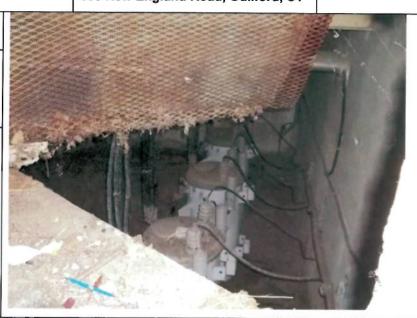
Photo No.

Description: **Electrical** Transformers and Vault

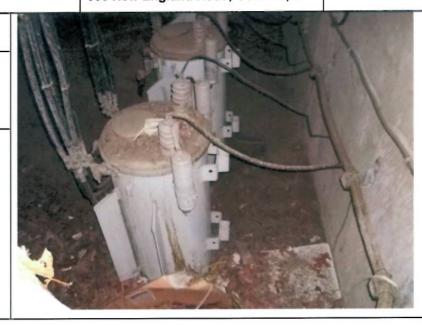
Photo No. 35 Date: 08/2012

Description: Electrical Transformers and Vault
